WATER POLLUTION (AND SANITARY) SURVEY  
of the  
WEST ANNEX AND HILLCREST SUBDIVISIONS  
TOWN OF COCHRANE

WATER POLLUTION AND SANITARY SURVEY

WEST ANNEX AND HILLCREST SUBDIVISIONS

June, 1971

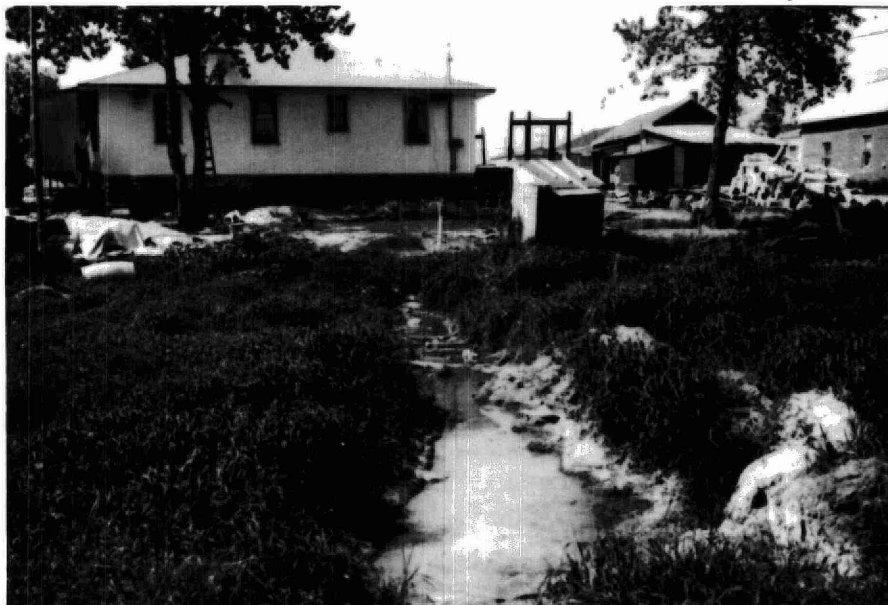
Ditch draining septic tank overflow  
at rear of 78 Huron Road (Photo 1)

B. <u>HILLCREST SUBDIVISION</u>				
Rear of 78 Huron Road	2	Ditch draining septic tank overflow. Very offensive odour noted. (see Photo #1)	80,000+	8,000+
89 Huron Road	4	Small ditch draining wash- water discharge from home. (see Photo #2)	80,000+	8,000+
Rear of 161 Algonquin	7	Septic tank overflow ponding at rear lot. Very offensive odour noted. (see Photo #3)	80,000+	8,000+
Rear of 19 Cree Road	17	Ditch draining septic tank overflow	80,000+	8,000+
88 Huron Road	3	Washwater discharge from home at 88 Huron Road to roadside ditch.	80,000+	8,000+

1. Sewers should be extended to the two subdivisions to clean up the existing problems. Also, further development in the two subdivisions should not take place until the areas are serviced by sewers.

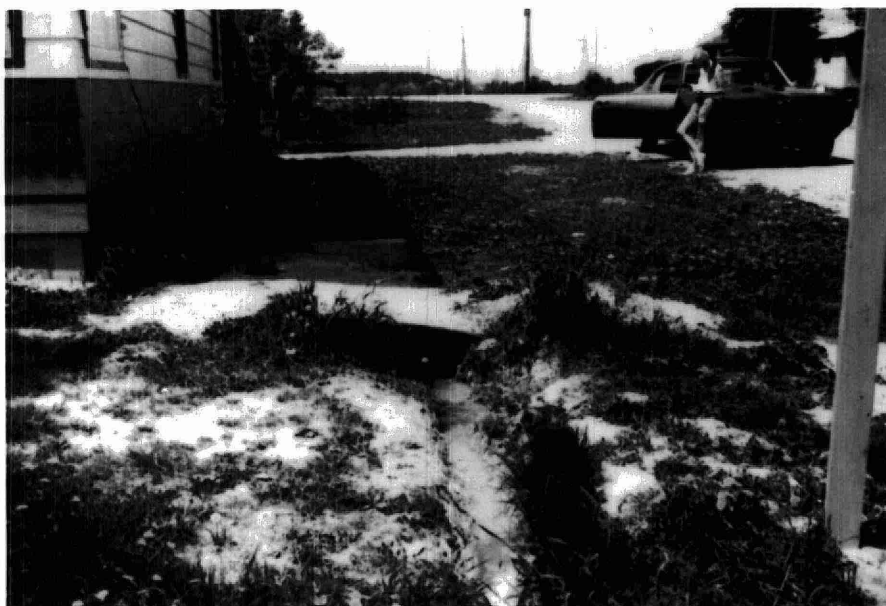
Visual evidence of pollutants was noted entering the drainage ditches. In some instances, it was noted that washwater was being discharged from homes directly to the drainage ditches via plastic pipes.

Small ditch draining washwater discharge  
from home at 89 Huron Road (Photo 2)

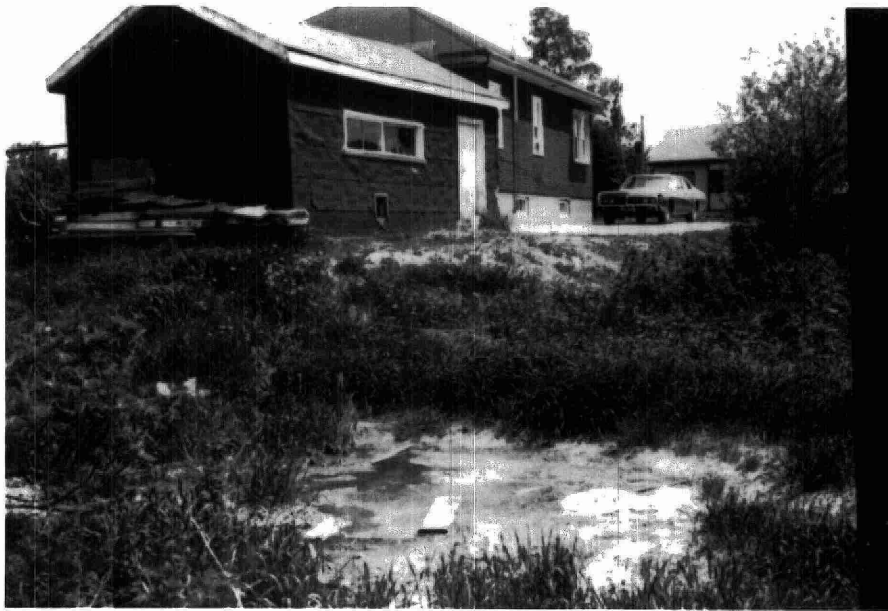
Septic tank overflow ponding  
at rear of 161 Algonquin (Photo 3)
